Innovative Technology for ADA Compliance and the Improved Safety of New Construction and Existing Track Crossings

Robert M. Loomis¹

¹The Willamette Valley Company, 1075 Arrowsmith St., Eugene, OR 97402. E-mail: rob.loomis@wilvaco.com

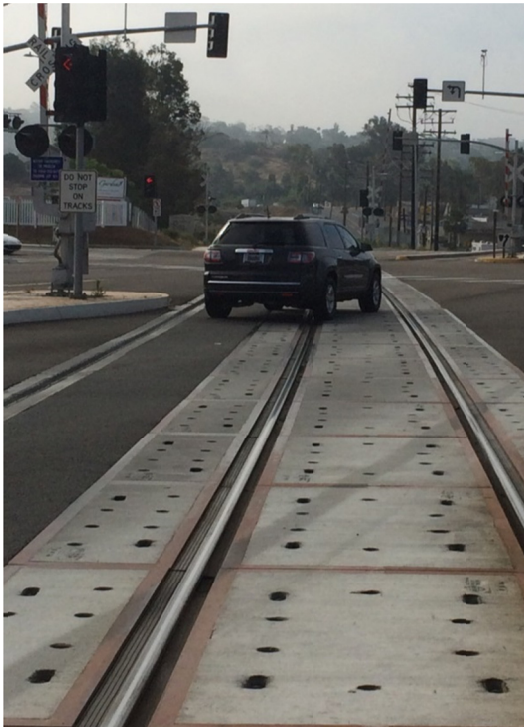
Figure 2: Angled crossing.

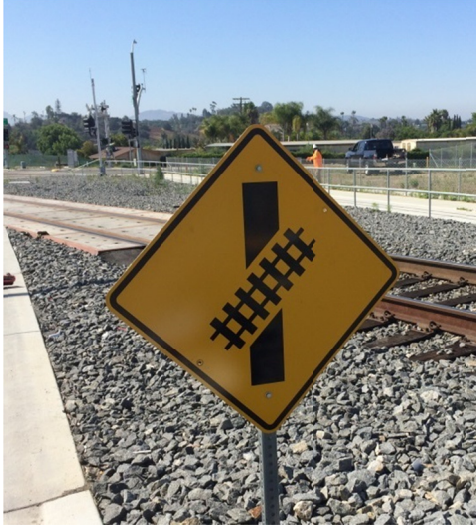
Figure 4: Warning of angled track crossing.

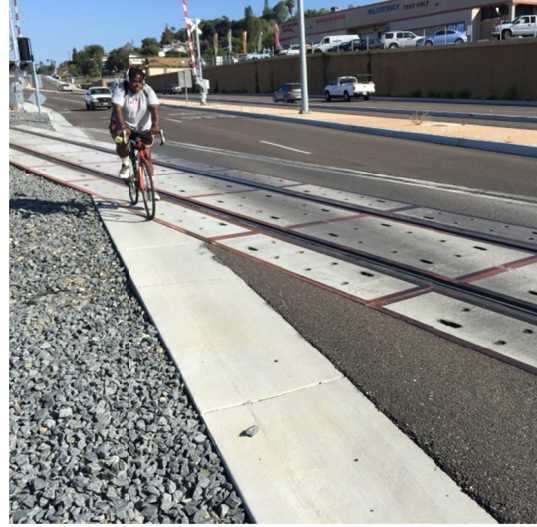
The example in the paper shows this exact hazard as the bicycle path crosses a track at less than 90 degrees (Figure 5). In such cases, filling the field gap and widening the bikeway to allow sufficient width to cross the tracks at a safer angle, will improve the safety of these crossings. (Grade Crossing Handbook, 2007).

Figure 5: Angled approach of bicyclist over gaps.

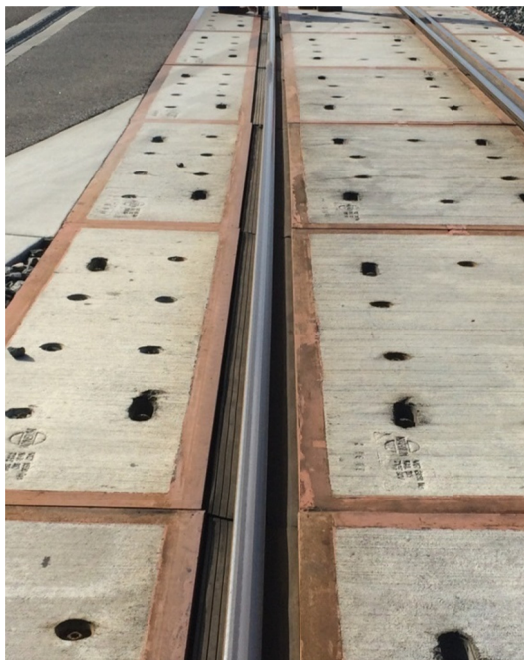
An innovative composite material was chosen to fill the gaps in a track crossing with a history of accidents due to hazardous gaps next to the rail. The material was provided in the form of kits and mixed according to the manufacturer's recommendation. The material was used to fill the gap between the concrete panels and field side of the track at the pedestrian crossing for ADA compliance and improved safety of two-wheeled traffic. The available track time for this work was 15 minutes between trains and this was enough time for the crew to clean the gap and install the material. The installation was monitored for several months and found to be performing according the expectations and the hazardous gaps have been eliminated.

Figure 6: Hazardous field-side gap.

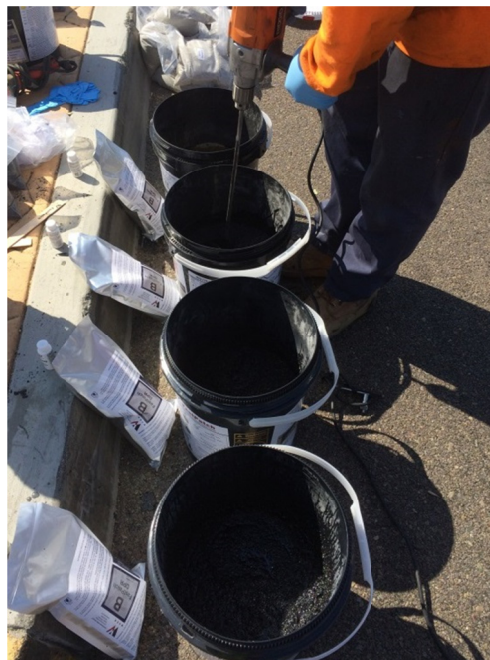
Figure 7: Staging material to fill gap on live track and traffic lanes.

1. Cleaned surfaces with a high velocity blower (250 MPH / 700 CFM) blower, removed moist and loose materials, and rust between train intervals (15 min). Surfaces were wiped clean with a towel. Ends were capped and surrounding surface taped.
2. Mixed the material according to manufacturer's recommendations and staged the materials until track was available.
3. Immediately after train clears the track, pour and spread material within the gap area and leveled to the surrounding panel elevation. Apply black topping sand to refusal and clear area for train and re-open to the traveling public.

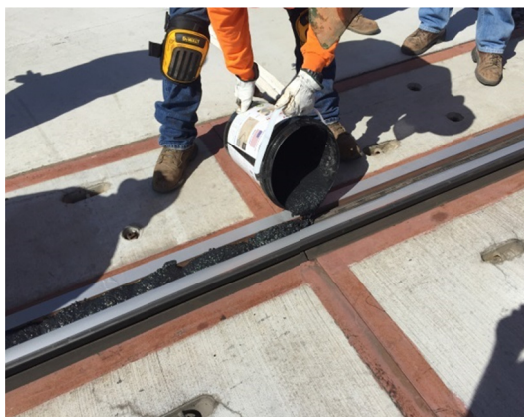
Figure 8: Installing material.

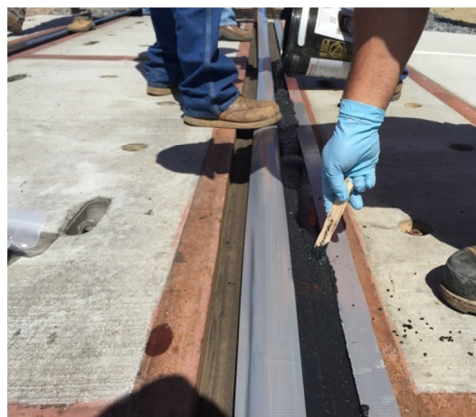
Figure 9: Leveling material.

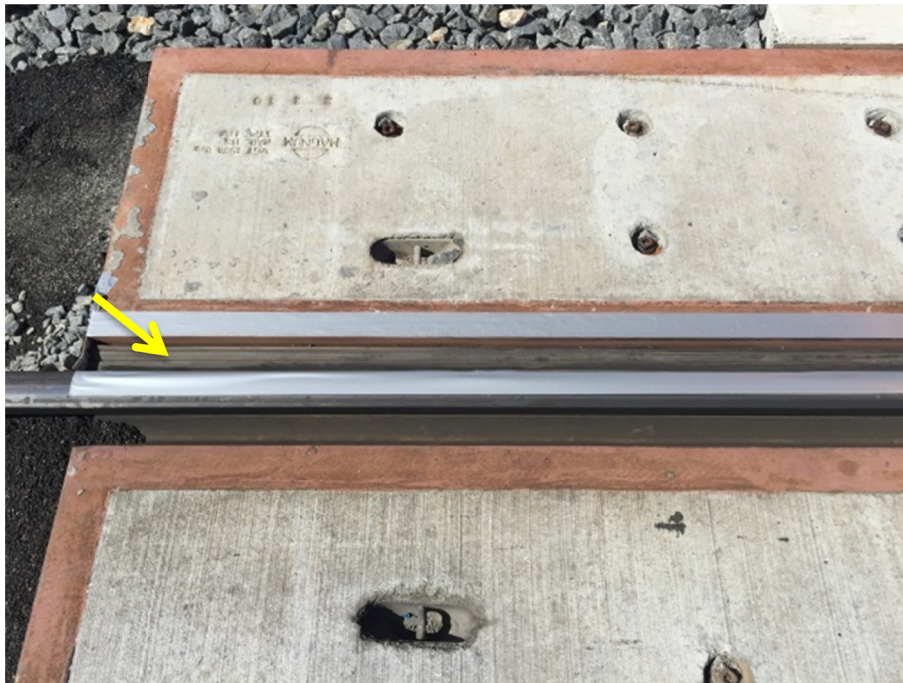
Figure 10: Unfilled hazardous gap (BEFORE).

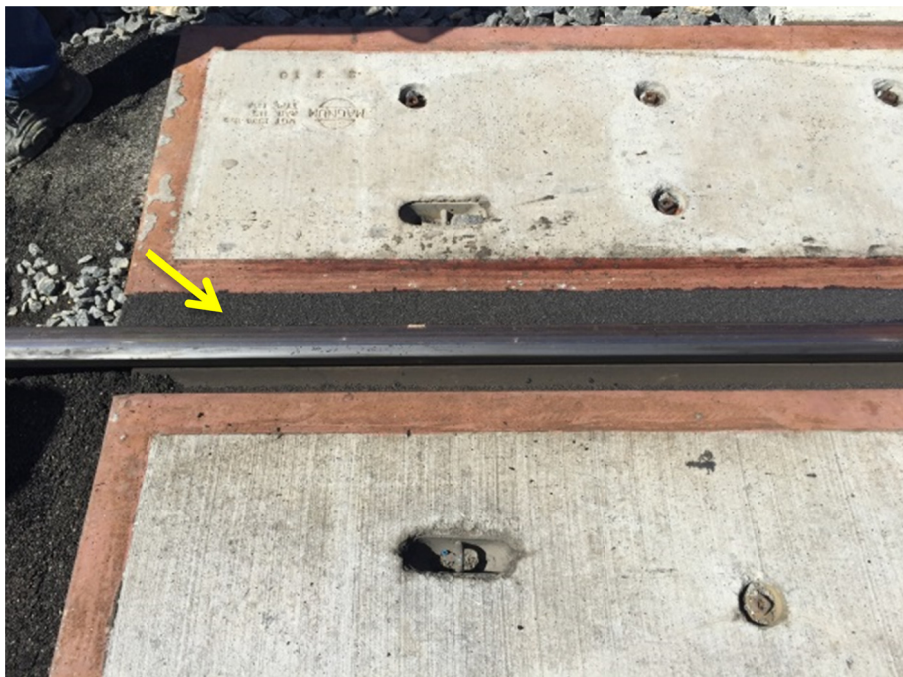
Figure 11: Filled gap with innovative material (AFTER).

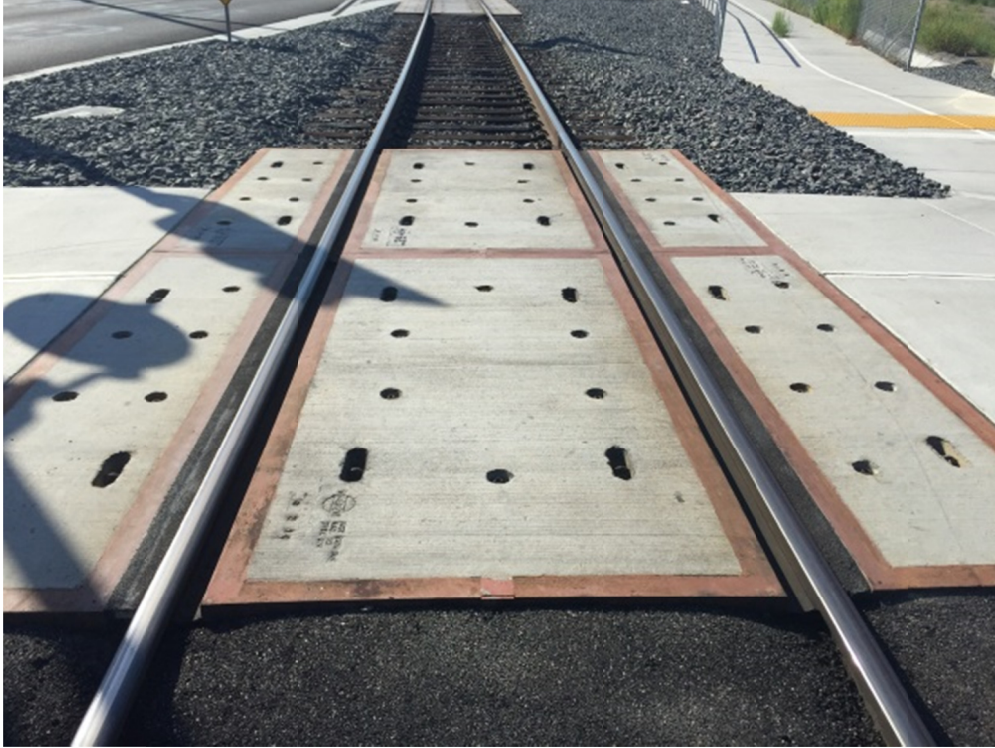
Figure 12: Crossing completed with innovative material.
