Change Challenge Cup Entry Gavin Silvey and Michael Hayes

**Track Lowering and use of
“SpikeFast” polymer filler**

Tube Lines

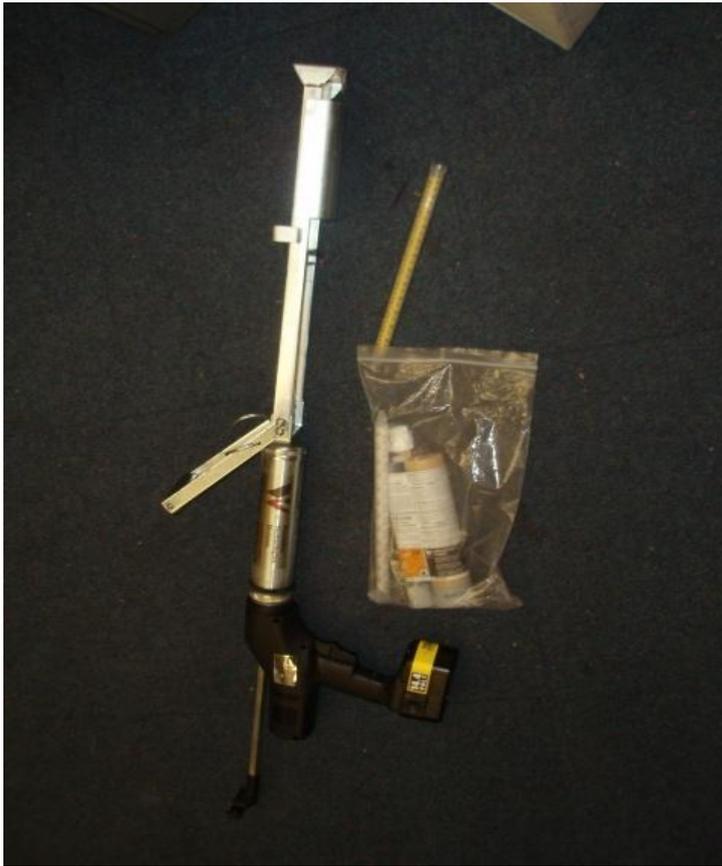
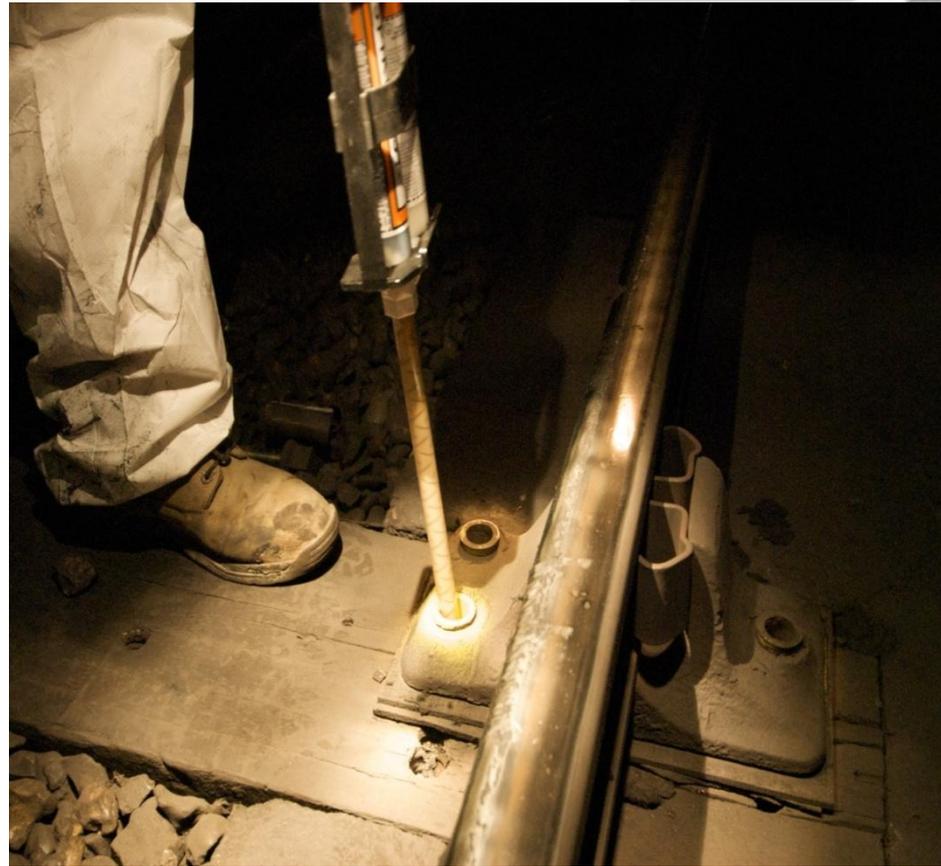
- SpikeFast® is a polymer compound injected into existing drilled holes in sleepers.
- SpikeFast enables the existing sleeper to hold coach screws to keep the chair/ baseplate in place, thereby extending the sleeper's life.
- SpikeFast hardens in 20 minutes and 1 x 450 ml tube can fill approx 8 to 10 holes.
- Existing holes filled with SpikeFast can be re-filled, with no deterioration in strength.
